Shawn Heiser  
Joanna Christion  
May 17, 2003

## Calera Creek Study

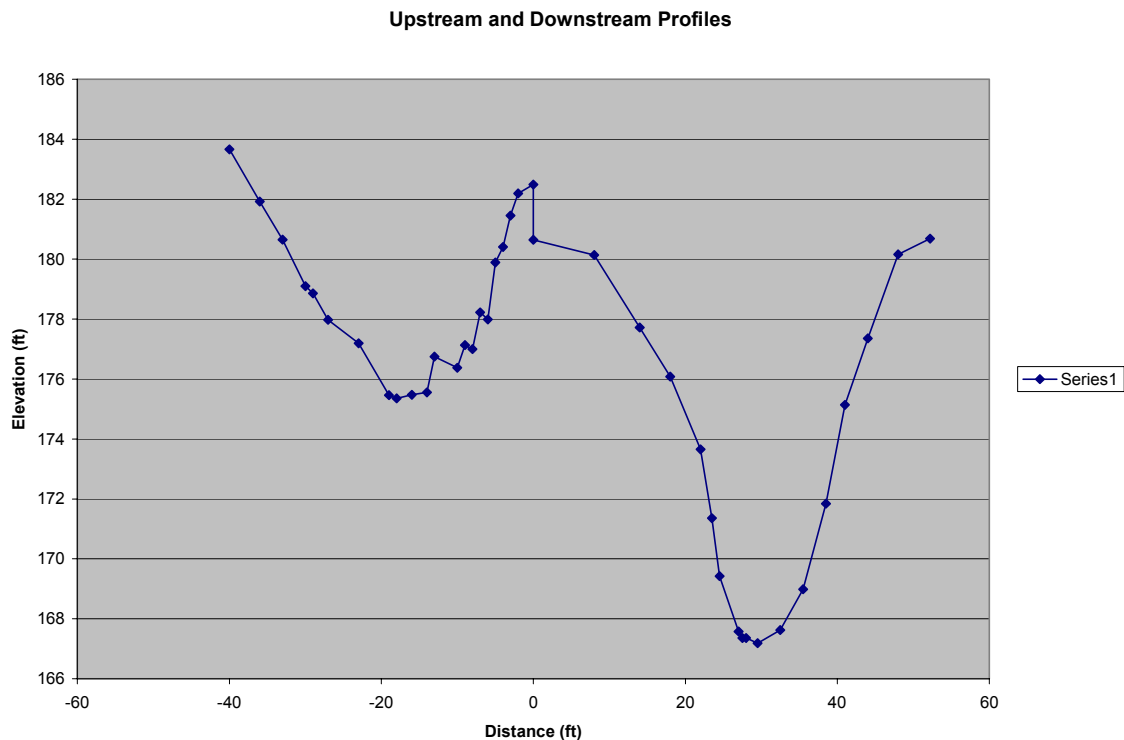
serve to give us both a width measurement and station markers (feet measurements on the tape). We started at the very top of the wall in order to determine our bench mark elevation which was 175 feet according to our topographical map. Starting from the top of the left bank Joanna began to take intermittent readings as Shawn descended down the slope calling out station numbers and substrate type. Twice bank-full and bank-full stations were identified and recorded also for future calculations. When Shawn reached the stream itself he also called out the waters depth at the thalweg. Between each station a new elevation was calculated and recorded. The same was done for the upstream portion of the creek. Our results after entering the data in an excel program expressed the predictions that we had made. The left cross-section is upstream while the right cross-section is downstream.

The effects of the wall on these two sections of the stream, which were only about fifty feet apart, were quite dramatic. It shows that there most probably has been a lot of fill above the wall, which would account for its noticeably shallow profile. The entrenchment ratio for upstream was 1.7. According to the Rosgen classification system this makes the stream above the wall moderately entrenched. The width to depth ratio for this section is 7.7, meaning that the stream is seven times wider than it is deep at bank full. The downstream profile also reflects our predictions, only more dramatically than we expected. As the water flows toward the wall the much of the heavier sediment is stopped by the wall, the water flows over, drops several feet and lands below. The impact of the water as it hits the stream bed below, causes scouring and down-cutting to occur in the lower stream bed. You can see that over the years the scouring has been severe. This scouring has resulted in a downstream entrenchment ratio of 1.4. Again according to Rosgen, the stream would be classified as entrenched. The width to depth ratio in this section is 5.5, meaning the stream is five times as wide as it is deep. This is again a number that we would expect because of the scouring which has caused the stream bed and bank to be cut so narrowly.

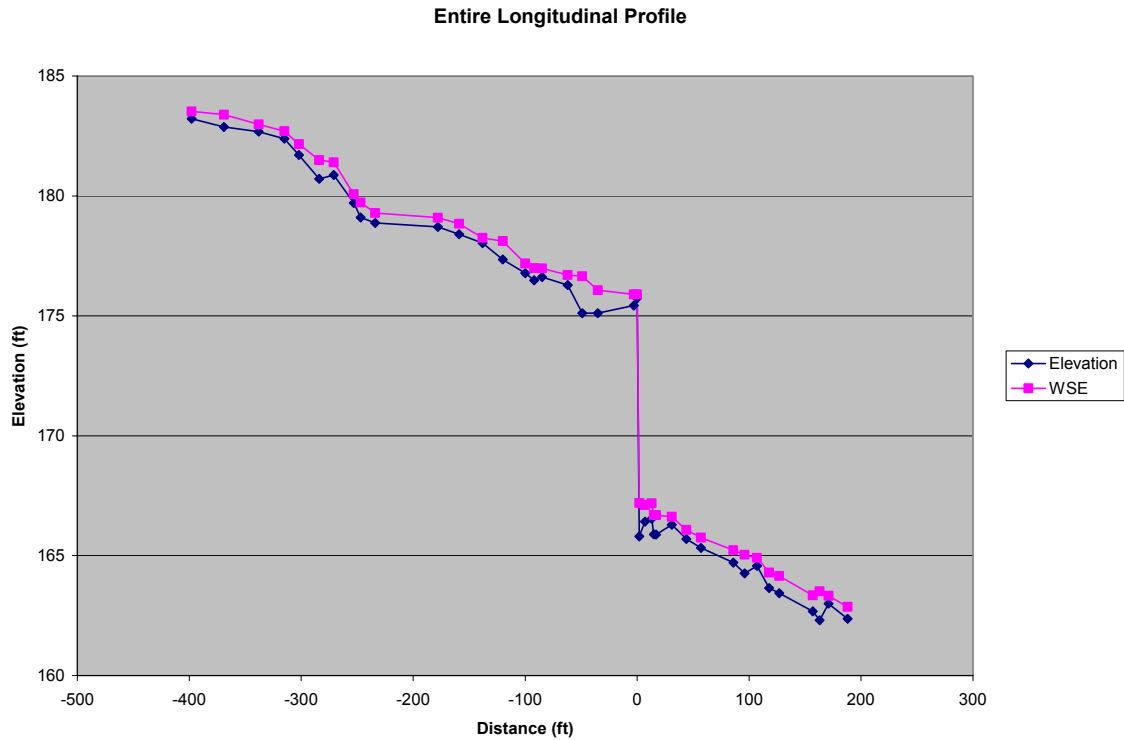
along the stream bed calling out station numbers, he also called out the substrate type as well. We expected the substrate to be rockier downstream and to have more silts and sands upstream due to the dam. After we had gathered all our longitudinal data for the downstream section of the stream we started the upstream portion. The difference with this section was that we studied four hundred feet rather than the two hundred feet downstream. We did this because we predicted that the dam would influence the longitudinal profile too much within the first two hundred feet of the wall. Therefore, we went back an extra two hundred feet in order to show any flattening of the stream as we got closer to the wall. We had to do several turning points to see the entire stretch of the upstream portion of our study. The turning points turned out to cause our stadia rod reader some problems. At the first turning point Joanna read the wrong cross hairs and threw the elevations off by one foot (what a retard)! We had to go back out, re-due all the turning points, and then correct all the data. We were successful however and we got interesting, but predicted results.

The stream was not as steep above the wall due to the sediment fill and the downstream portion was a bit steeper due to all the scouring and down-cutting. As Shawn tromped through the creek he also noticed that the fill above the stream created a much muddier, softer stream bed, while the downstream portion had a more rockier, firm feel to it. This was as predicted. This graph also nicely illustrates the extreme difference in elevation between the two reaches. The slope upstream is .020, which is fairly steep. We derived the slope by dividing the change in water surface elevation (7.64ft) by the length of the stream studied (400 ft). The downstream slope was derived by dividing the change in water surface elevation (4.33 ft.), by the length of stream studied (200 ft), and we found a slope of .020. The slope of the valley is .03. We derived the slope by using the elevation change on the topographical map divided by the length of the valley. Using

both the stream slope and the valley slope we derived our sinuosity for upstream to be .67, (.020/.03), and the sinuosity downstream to be .73 (.022/.03). These calculations put the upstream portion into the B classification and the downstream portion into the G classification according to Rosgen.

The effects of the wall on this stream are easy to see visually; however deciding what other effects there may be as a consequence to this wall is a little more difficult. For example what are the effects on migrating animals? Frogs and salamanders may be able to get around it. Fish and micro-invertebrates on the other hand would absolutely not be able to get upstream past that wall. So what is the possibility of removing this cement wall? That is hard to say. The ten foot difference in elevation between the upper and lower portions of the creek would be quite a challenge for removal. The fill in the upper portion would have to be dug out, and possibly put in the lower portion of the creek in order to lower the upper portion and raise the lower portion. In order to prevent mass loss of soil you would possibly have to divert the stream and add plenty of gravel, cobbles and boulders while you adjusted the elevations. This would be hard in this particular area though because of the entrenchment. Regardless of how the wall is removed, it would be a difficult and costly venture.
